Investigations on the breakdown of a heat recovery steam generator during the initial operation run

D. Bettge*, C. Klinger, D. Klingbeil, A. Eberle

Federal Institute of Materials Research and Testing (BAM), Berlin, Germany

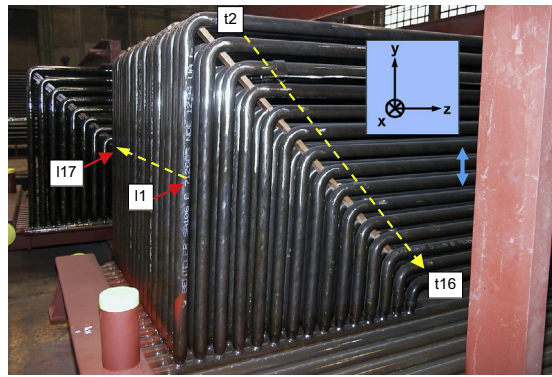
Fig. 4. Evaporator module fixed in a transport cradle. The tubes are numbered from “t2” (largest) to “t16” (smallest). Tube stacks are arranged from front to back in this image (numbered “l1” to “l17”); finned wall at the bottom, wooden laths left from manufacturing; vibration direction was in y-axis (blue arrow). (For interpretation of the references to colour in this figure legend, the reader is referred to the web version of this article.)

The fact that only about 2% of the tubes of the evaporator modules showed cracks reinforces the information that at some stage of the handling a few of the laths plugged in between the stacks of tubes for sake of damping were displaced. Experimentally and numerically supported analyses concerning the comparison between the loading stress and the fatigue limit of the bends showed that in case of a missing transportation safeguard the loading stress considerably exceeded the strength of the bends which inevitably may have induced fatigue failure. It is assumed that cyclic stresses did not exceed the fatigue limit when transportation safeguard were present.

In consequence, as a corrective step a more effective prevention of transport vibrations was recommended. The transport locks had to be re-designed and realized consequently.

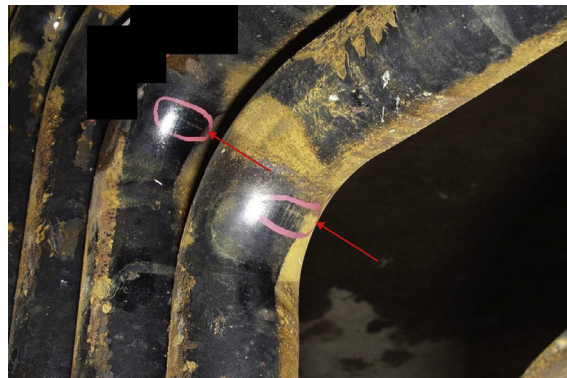
Fig. 6. Cracks (see arrows) found at the surface around the apex of the pipe bend in an evaporator module during on-site inspection.

As soon as the assembly of the steam generator at the site of operation was finished, the whole unit was tested for leak tightness by a hydraulic pressure test using twice the operating pressure. No indications for leakage were reported. After this, a test run involving the air blower was performed covering a range of 72 h at 50% of the rated power and at a temperature of 240 °C. After this run the following test for leak tightness revealed leakages within the evaporator modules, Fig. 6,

it. This finding coincided with the location of the cracks documented during fractographic evaluation of the original failed tube bends, Fig. 6.

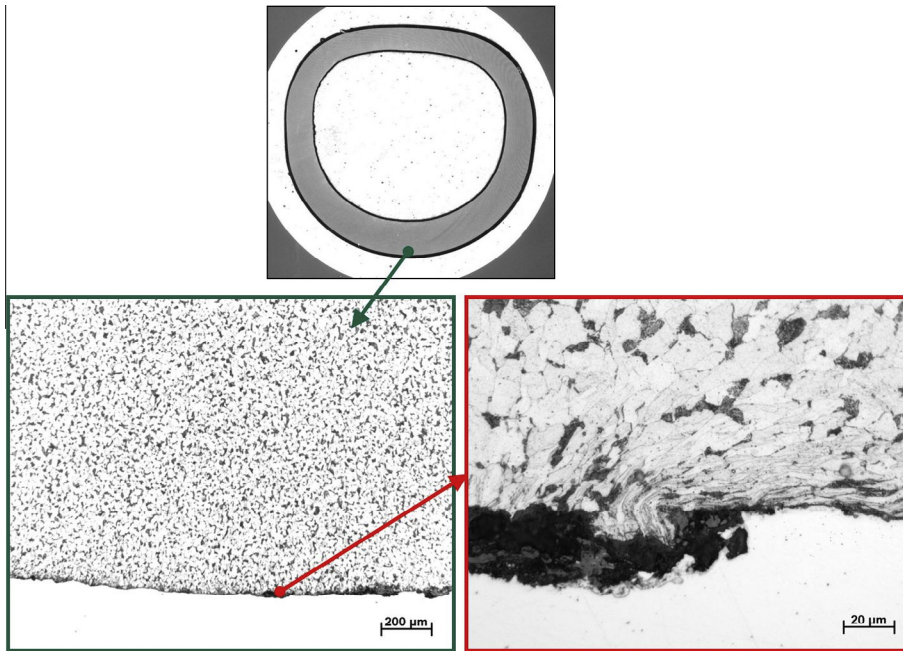
The microstructure of the material of the evaporator tubes was analysed in general and especially at the pipe bends. In this paper only the microstructure of the bended sections is discussed. The images shown in Fig. 11 focus on the inner radius of the elbow near the crack. As expected, a ferritic–perlitic microstructure was observed. Distinctive plastic deformation and

material overlap was found at the surface due to the bending process. It may be stated in advance that during the fractographic investigations it was seen that these surface features did not act as crack starters.

Fig. 11. Metallographic investigation of the microstructure of a cracked evaporator tube. For location of the cross section see Fig. 10. The cutouts focus on the inner radius near the crack. The microstructure is ferritic–perlitic. Plastic deformation at the surface is due to the bending process. The dots of the arrows give representative areas, not exact locations.

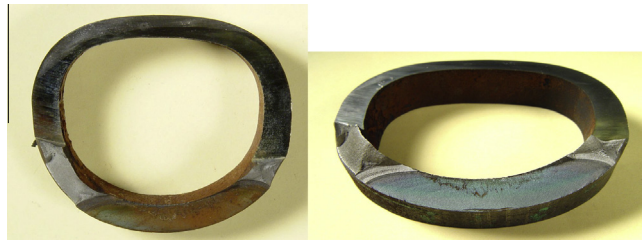
Fig. 12. Rings cut from the pipe bend of Fig. 10 containing the opened crack of Fig. 9. Lefthand: as opened; righthand: after removal of rust using citric acid.

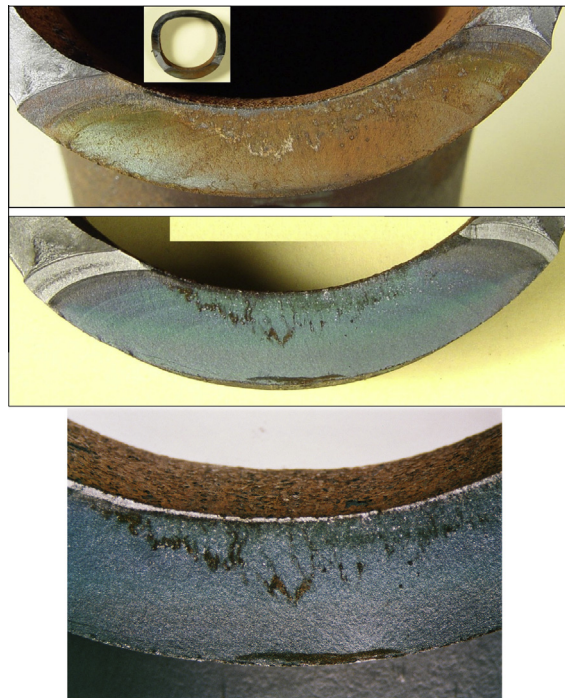
After opening the cracks using the test machine shown in Fig. 9 the crack surfaces were prepared for fractography. Fig. 13 shows a photography of each of the two crack surfaces of an opened crack. The top view shows that the crack surfaces were

clogged with coloured oxide layers, which were overlaid by rust. Nevertheless the circumferential character of the crack propagation may be noticed by a fine structure of rest lines. With the rust carefully removed using citric acid the graduation between the annealing colours was intensified and the rest lines between these colour schemes became clearly visible. A further series of cracks were opened and prepared for even the same detailed investigations and showed almost similar features, Fig. 14. From the documents of the operator regarding the pressure test runs it was not completely verifiable whether some of the pipes exhibited leakages already during testing. As a matter of fact, out of 7 cracks that were examined in the laboratory 5 were not yet cracked through the wall.

Fig. 13. Fracture surface found after opening a cracked tube. Enlargement of Fig. 12. Top: as opened; middle: after removal of rust using citric acid. Rest lines and annealing colours were found on the fracture surfaces, bottom: middle section, showing that coloured crack growth region has not grown through. (For interpretation of the references to colour in this figure legend, the reader is referred to the web version of this article.)

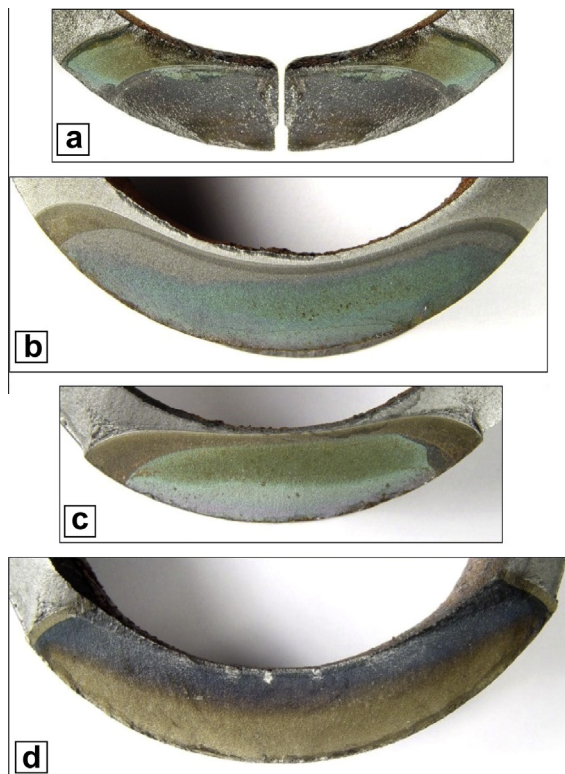
Fig. 14. Several additionally opened fatigue cracks imaged after rust removal by citric acid. The image of crack (a) was reconstructed from the previously separated crack surface.

- Some cracks did not yet cause leakage, though, the circumferential crack propagation was already considerable, e.g. for cracks (b) and (c) in Fig. 14. This meant that the radial crack propagation was retarded. In case of semi-elliptical cracks this is a known phenomenon because crack propagation is mainly forced towards the very part of the ligament exhibiting the highest amount of triaxiality (this is the ratio between the hydrostatic and the equivalent stress). Regarding the present 3 dimensional stress state, the highest triaxiality should arise where the crack front is closer to the outer surface of the tube wall [4].

It seemed to be the case that at least in some instances the leakages developed very lately during crack propagation. Referring to cracks (a–c) in Fig. 14 the first phase of crack propagation did not lead to leakage. This implied the hypothesis that in some of the investigated tubes a first loading sequence caused a large amount of crack propagation, whereas later, a second loading sequence caused leakage.

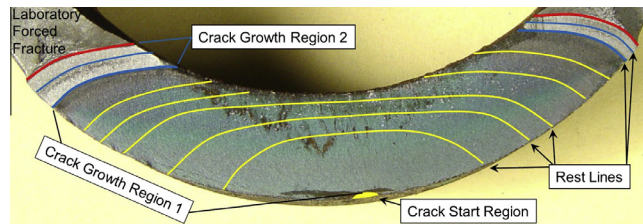
In order to illustrate the history of crack propagation by means of the crack surface of Fig. 13 in a better way, Fig. 15 was created. For this sake the crack starter point and several rest lines of semi-elliptical shape were plotted onto the crack surface in yellow colour. It may be seen that the crack not only propagates radially through the wall but even quicker circumferentially around the pipe wall. Adjacent to the circumferentially propagating crack and right in front of the surface from forced fracture by the laboratory a grey coloured crack area may be noticed ending with rest lines plotted in blue.

Taking the crack surface due to forced fracture by the laboratory unconsidered, the crack surface causing failure might now be divided into two zones of crack propagation. The first zone extends from the start of the crack along multiple yellow plotted rest lines to its final crack front plotted in blue. The crack surface is characterised by distinctive annealing colours and is denoted as fatigue crack growth region 1 in Fig. 15. In most cases the annealing colours on this first propagation area showed no correlation with the rest lines and, thus, might not be correlated with the crack propagation. This could be an indication that the annealing colours have been applied after this first period of crack propagation came to an end.

The second zone is characterised by a relative short crack propagation compared to the aforementioned zone of fatigue crack growth region 1 and propagates only along one blue rest line to the final crack front plotted in red. The related crack surface shows only weakly developed annealing colours. This zone is denoted as fatigue crack growth region 2 in Fig. 15.

Fig. 15. Macroscopic characteristics of an opened crack surface. Crack starter and semi-elliptical rest lines (yellow) of fatigue crack growth region 1. Subsequent propagation of fatigue crack growth region 2 (blue rest lines) until final crack front (red lines). Forced fracture by crack opening in the lab (adjacent to the final crack front).

- All cracks were fatigue cracks [1,2].
- The crack starter region always was located at the outer surface of the wall at the inner radius of the pipe bend, Fig. 15.
- The crack front was of a semi-elliptical shape as usual for fatigue cracks in circular tubes under bending loads [3].
- The crack surfaces were nearly planar.
- The crack plane was located some millimetres away from the apex of the elbow at the inner contour (intrados = ID). As long as the 45° apex plane is a plane of symmetry with respect to the geometry, loading and boundary conditions, the maximum normal stress will occur at this position. As soon as geometry as well as loads deviate from that symmetric condition, the stress maximum and, hence, the crack will no longer occur at the apex but at a small distance away from it. In Fig. 9 the apex of the elbow is indicated by the circumferential line.

- The misalignment of the annealing colours with regard to the specific crack propagation zones on the fracture surfaces. From Fig. 15 it may be seen that the rest lines of crack growth region 1 are not aligned to the boundaries of the annealing colours. Thus, it is evident that the annealing colours must have been generated after the crack had propagated.
- The two distinct zones of fatigue crack propagation (fatigue crack growth regions 1 and 2).

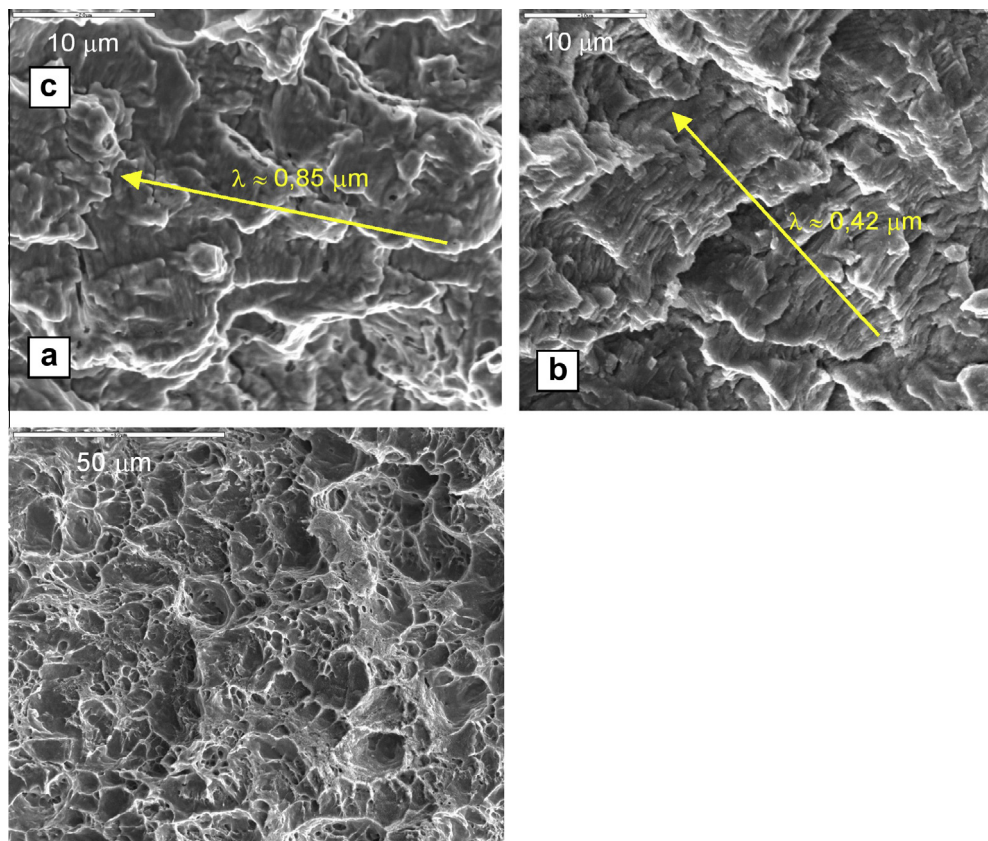
Fig. 16. SEM investigations of the fatigue crack. (a) Fatigue crack growth region 1 in Fig. 15: fatigue striations at the area near the end of the primary crack phase; (b) fatigue crack growth region 2 in Fig. 15: fatigue striations developed during the second phase of fatigue crack propagation; (c) laboratory forced fracture surface showing dimples.

The SEM was used to analyse the microstructure of the crack surfaces. In Fig. 16 details of the analysed crack surface from Fig. 15 are shown. The former assumption of dealing with fatigue cracks was confirmed. Fatigue striations were identified in both zones of the crack surface of Fig. 15. The arrows in images (a) and (b) of Fig. 16 indicate the particular direction of crack propagation. By counting the number of striations for a certain length of crack propagation, an average width λ could be calculated for fatigue crack growth regions 1 and 2, respectively. Although this may be seen as estimation, it may be stated without doubt that the velocity of crack propagation of fatigue crack growth region 1 was generally higher than that of fatigue crack growth region 2.

Beyond the fatigue crack areas of the crack surface a honeycomb structure was found indicating ductile forced fracture due to crack opening. Furthermore this indicates that the material was able to undergo ductile deformation.

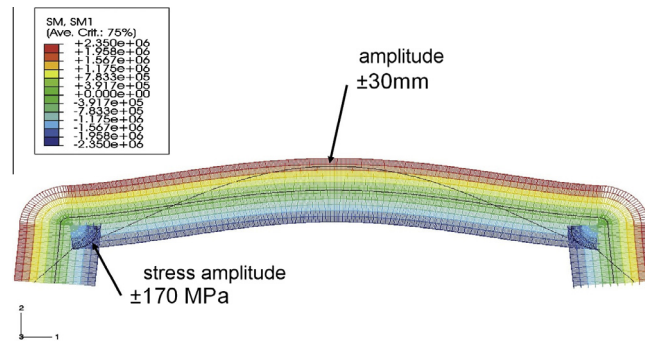
Using FEA the kind of stresses that would arise in the tube bend during vibration was simulated. Different vibration modes and their resonance frequencies were examined. The highest stresses emerged when vibrating in the first eigenform, as shown in Fig. 20. It was taken into account that the tubes were able to move at most 30 mm up and down. This deflection is half of the gap between each of the horizontal tubes of each two loops. The loops in a bundle are of different sizes in order to assemble them as a stack from small to large. Thus, it was postulated that each of the horizontal tubes should vibrate within the vertical plane of the stack with its own eigenfrequency and not in unison with other tubes. If the vertical deflection was to exceed 30 mm it was supposed that the horizontal tubes of each two loops would pound at each other. The highest computed tension and compression stresses were identical and around ± 170 MPa. These stresses were located on the surface of the tube walls at the inner bend of the elbows (intrados = ID). The exact location was not at the apex of the tube bend, but some millimetres away. In our numerical simulation, the absolute values of the stresses on the ID and OD (extrados = OD) are identical because we used pipe elements with circular cross-section. This means that from the numerical simulation alone it cannot be decided whether a crack occurs on the ID or OD. After bending, the cross-section of the pipe is irregularly ovalised and no longer circular, Fig. 11. Typically, the distance from the centre of the cross-sectional area to the ID is longer than to the OD. This causes slightly larger stresses on the ID and results in cracks on the ID. Additionally, due to a fully plastic state of stress during manufacturing and spring-back after load release, tensile stresses will remain on the ID and compressive stresses on the OD. In case of the ID, the stresses from the manufacturing and loading have to be added whereas on the OD they have to be subtracted. Overall, these arguments imply higher tensile stresses on the ID than on the OD. As soon as the geometry (cross-section) as well as loads (deflection) of the structure deviate from a symmetric alignment the stress maximum will no longer occur at the apex of the pipe bend but at a small distance away from

Fig. 20. Simulation of the stress distribution of an evaporator tube being deflected by an amplitude of 30 mm in the middle. Maximum tension stresses occurs at the tube bends. The legend shows values of the section moment.

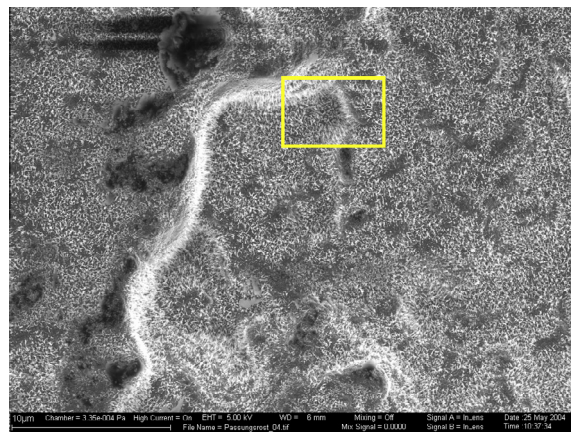
Fig. 25. Part of the fatigue fracture surface of an original fatigue crack, see crack surface (c) in Fig. 14. The crack surface is coated with small iron oxide whiskers.

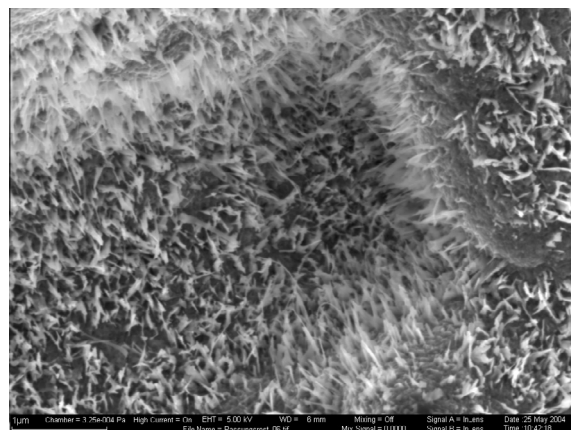
Fig. 26. Enlargement from Fig. 25. Iron oxide whiskers on the crack surface after annealing.
